# Rail Removal Tool

## PROBLEM

## SOLUTION

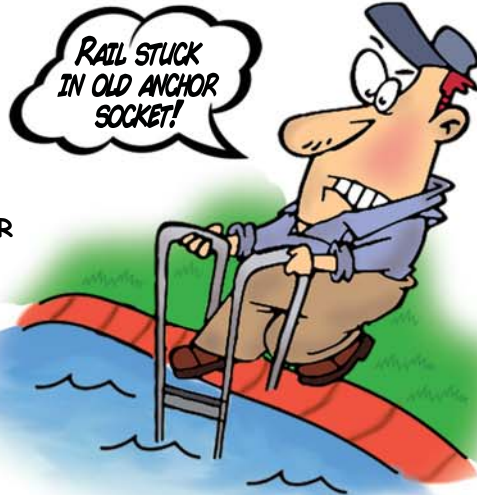
WHEN THIS LADDER WAS ORIGINALLY INSTALLED, THE BUILDER ALLOWED CONCRETE TO PLUG THE DRAIN HOLES IN THE ANCHOR SOCKET. OVER TIME WATER FILLED THE ANCHOR SOCKET AND GALVANIC CORROSION OCCURRED. OVER LONG PERIODS OF TIME CORROSION PRODUCTS BUILT UP BETWEEN THE POOL RAIL AND THE ANCHOR SOCKET, WEDGING THE RAIL IN PLACE.

THE RAIL REMOVAL TOOL UTILIZES THE VIBRATION CREATED BY A COMMERCIAL HAMMER DRILL TO LOOSEN AND REMOVE THE CORROSION PRODUCTS FROM THE ANCHOR SOCKET. AFTER REMOVING THE RAIL, THE DRAIN HOLES IN THE ANCHOR SHOULD BE OPENED TO AVOID FURTHER PROBLEMS DOWN THE ROAD.

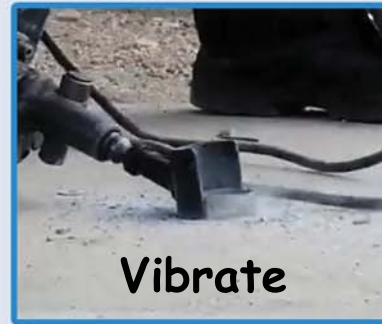
PART #  
RRT-Chisel

Vibrate

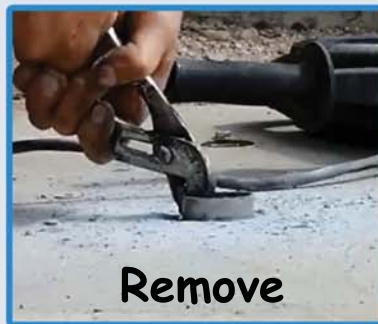
Remove

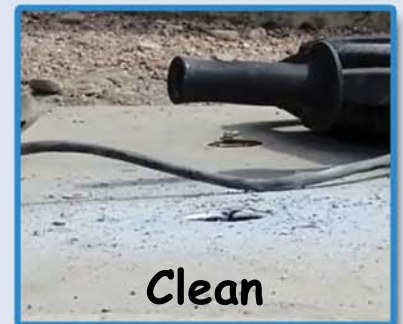
Clean
